Duramax LB7 Injector Line Corrosion

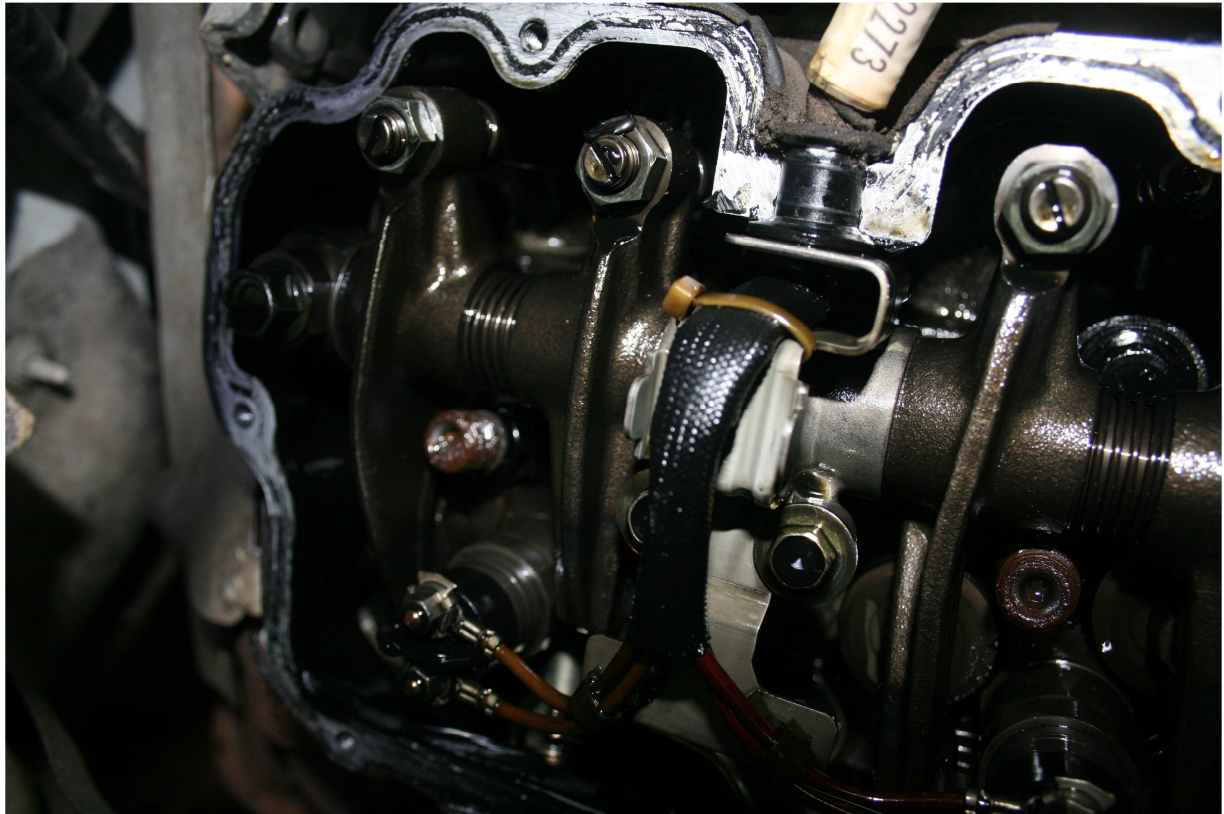
The Duramax LB7 uses an injector line with an extended length nut in order to project through the rocker cover yet seal to the cover. This line nut seals to the injector at the very bottom via oring as well as the metal to metal high pressure junction of the tapered seat. The line and line nut are open to atmosphere above. The idea is that if the tapered seat were to leak, the fuel could easily escape the engine rather than leaking into the crankcase. While this design is smart in some ways it creates a major issue. The line nut to line interface is exposed to debris and sediments that collect inside and corrode both the nut and the line. During the course of normal operation, this is not an issue as this corrosion is external to the tapered seat seal, but once the line nut is turned the corrosion is ground up and deposited into the inlet bowl of the injector as shown below:

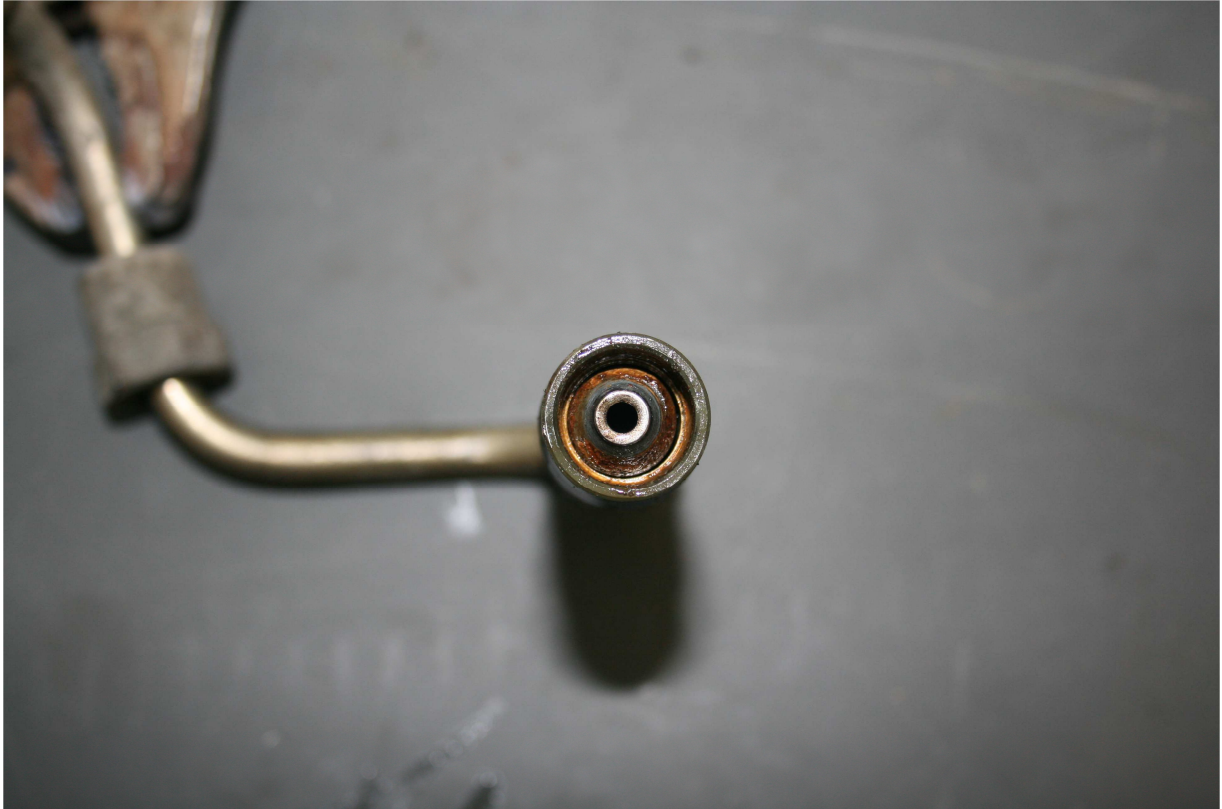
This material can be cleaned out and flushed from the injector, but cannot be cleaned from the line itself. The image below shows the line taper and the definitive break between the sealed area and the affected area.

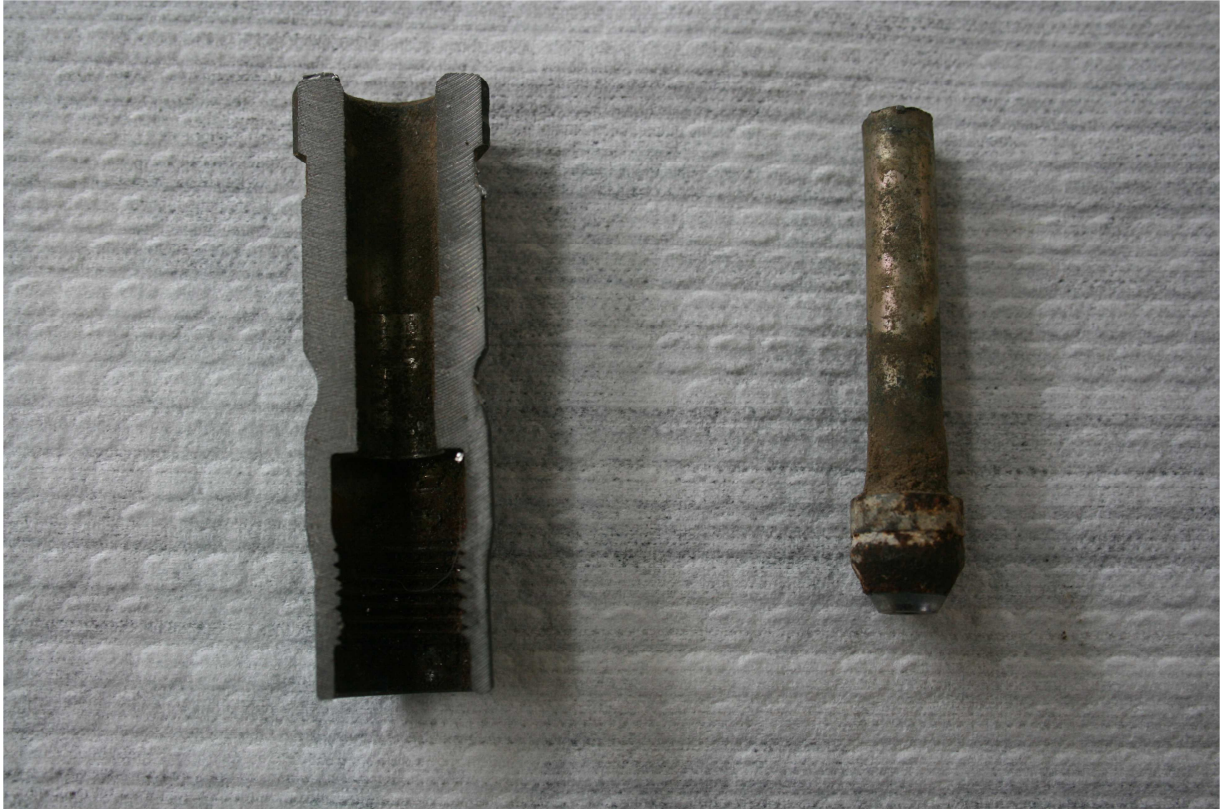
At a glance one would think that a simple cleaning of the tip of the line taper would suffice, but the reality is that this corrosion is on the inside of the line nut in the threads as well as up the shaft of the line around the entire seating ball. The line nut cannot be slid back enough to expose the seating ball so I sectioned one as shown below:

In my opinion it is just not practical to clean these lines. As soon as you begin to twist to thread them on the deposited crud up above will once again grind up and gravity feed into the injectors which in most cases are being replaced at this point. In other words the first thing your new injectors see is a dose of highly abrasive contamination. A turd sandwich so to speak. For this reason we replace all 8 supply lines. Once assembled I will use a spray lubricant like Eezox Gun Care or CRC Spray dielectric grease to form a protective coating and to prevent corrosion. While some have suggested sealing the line to nut with silicone I do not endorse this position. This junction will likely never be a positive seal regardless how good a job you do. With an imperfect seal comes breathing and with breathing comes moisture condensation and with moisture condensation comes corrosion. In other words the sealer will only keep out large contaminants. To illustrate this theory take a piece of steel tubing and weld a cap on each end. Leave one end imperfect and set outside. In time you will catch water inside this tube especially in humid climates.
