# Garrett Dmax VGT turbo vane control sticking issues

Commonly associated with DTC P2563 P2564 and P003A on LLY LBZ and LMM Duramax engines.

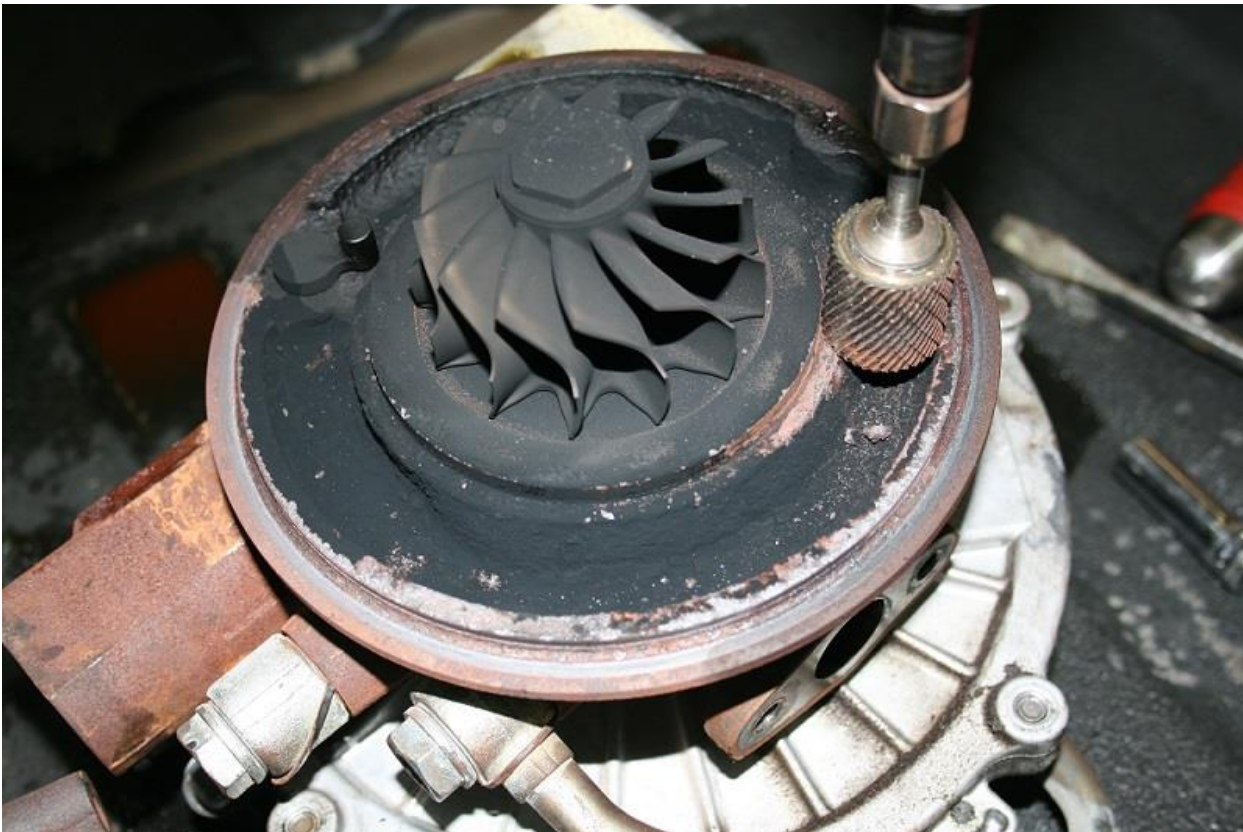
Once apart I needed to pry the unison ring off the pilot. It was stuck that bad. Be sure to inspect the unison ring to make sure it is not cracked. If it is cracked the crack should be pretty obvious and typically on the inside diameter. To clean I started with a square cut carbide burr and went around cleaning the base and the hub surfaces until the ring set on freely.

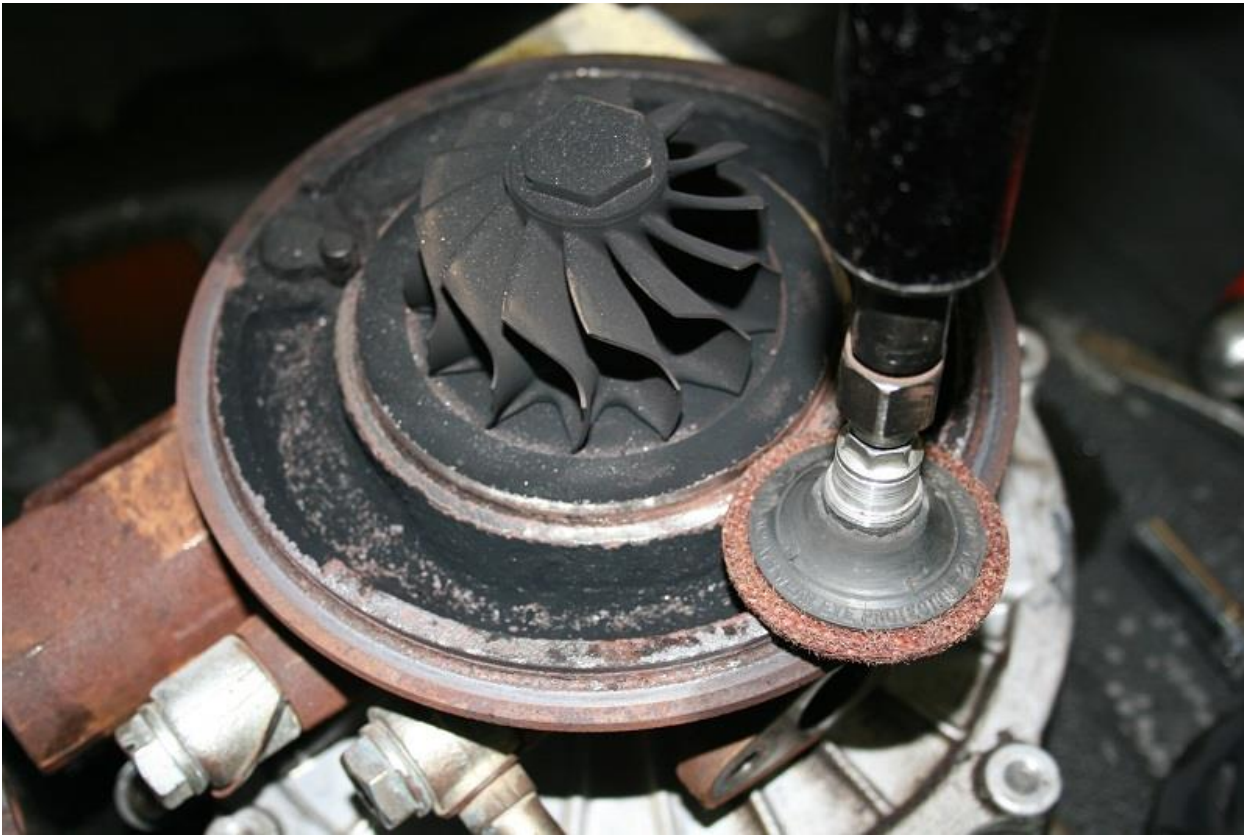
Following the carbide burr I switched to a Roloc type disc. It took a few discs as they wear out quickly.

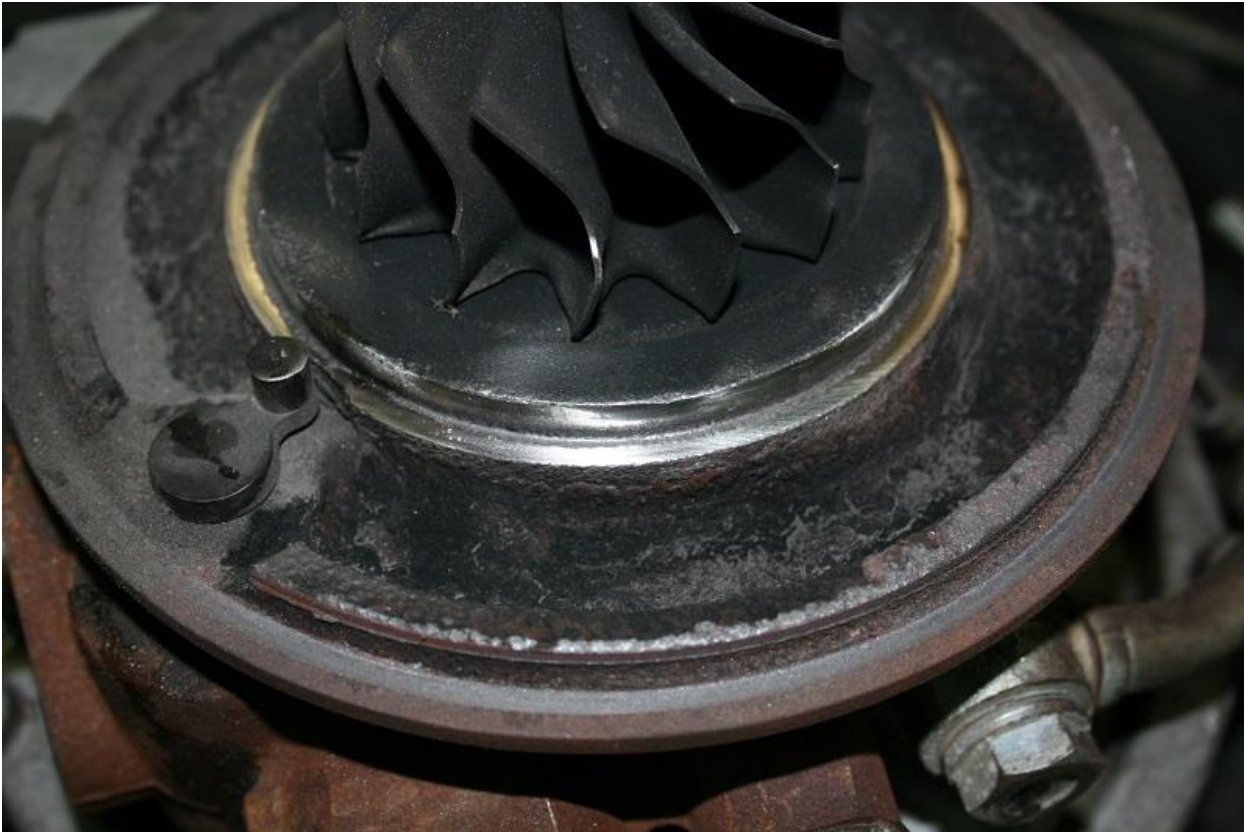
The finished surface has a nice polish to it. I smear this with a liberal coat of dielectric grease to it. The polished finish plus the grease will hopefully prevent repeat corrosion but only time will tell.

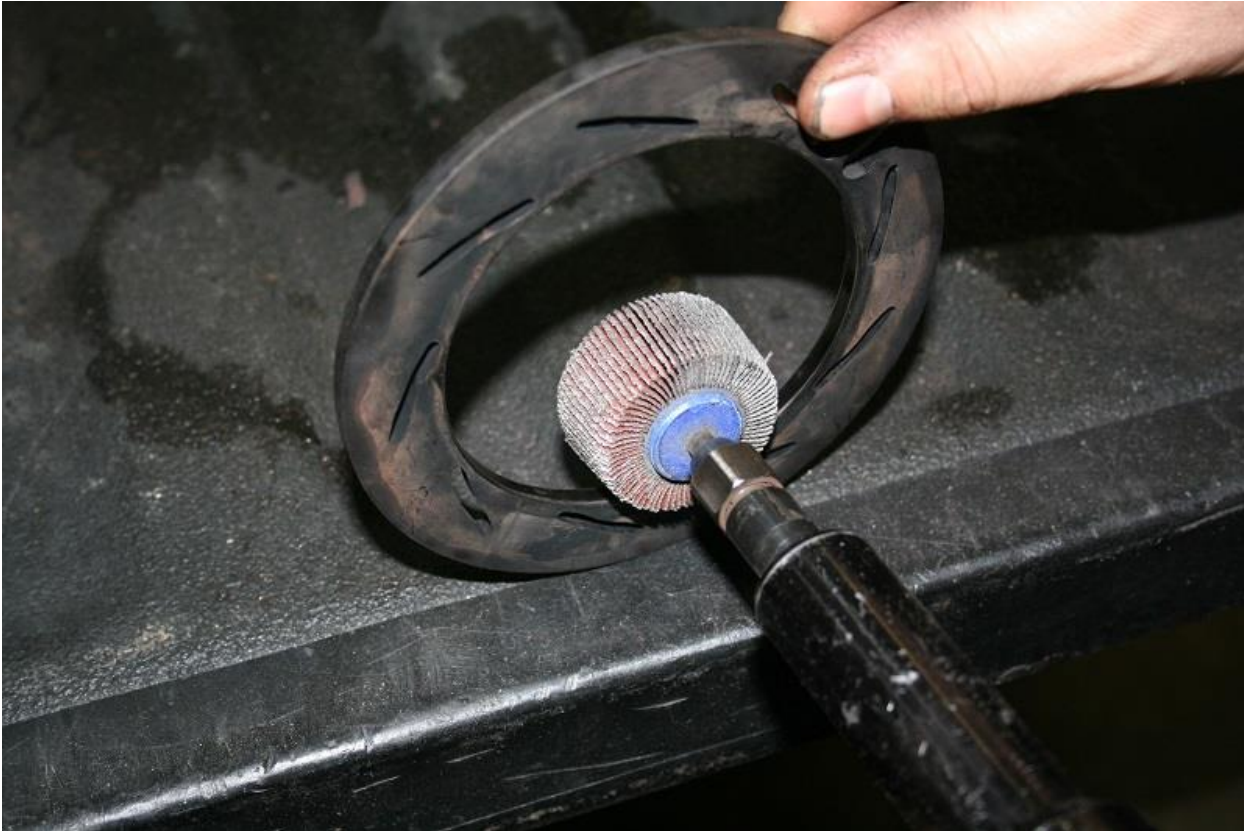
Just for grins I run a flapper wheel on the ID of the unison ring to clean it up a bit but there is typically little to no buildup here.

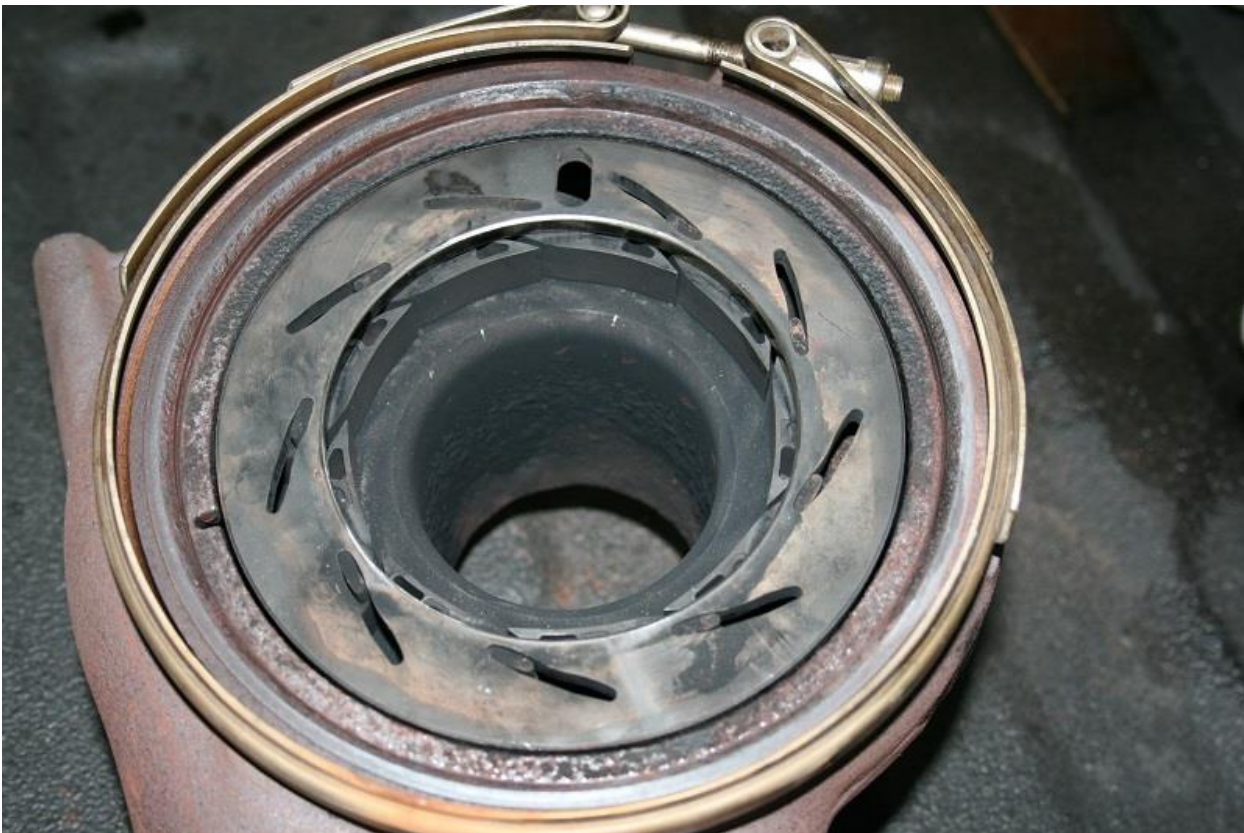
Once the ring is installed you should see that not only does it drop right onto the pilot, you will have some decent clearance. You will then need to align the vanes in the unison ring along with the slot for the control lever.
